NATIONAL TRANSPORTATION SAFETY BOARD

Factual Report

OPERATIONAL FACTORS/HUMAN PERFORMANCE

DCA19MA086

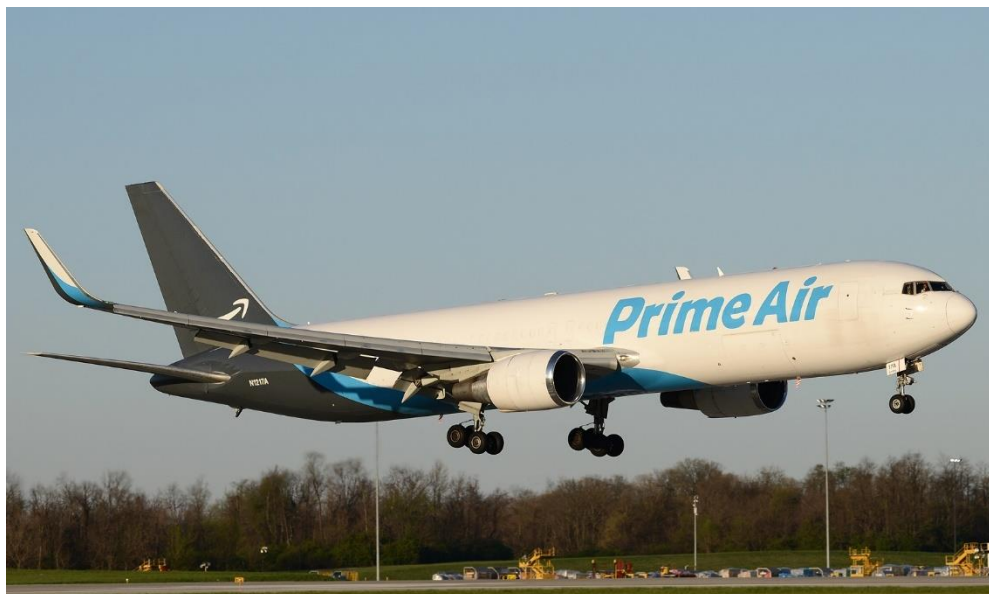
Photo 1: Accident airplane N1217A.¹⁰⁶

The accident airplane was a Boeing 767-375BCF (Boeing Converted Freighter), registration number N1217A, serial number 25865, and was manufactured in 1992. It had an airworthiness certificate dated June 6, 2017. It was a fixed wing multiengine transport category aircraft with 2 turbine air generator engines (CF6-80C2B6F) with winglets installed on each wing, and configured for cargo operations. It was registered to Andromeda Leasing I, LLC in Purchase, New York. According to maintenance records, the airplane had 91,063.02 total flight hours with 23,316 total flight cycles at the time of departure from MIA on February 23, 2019.

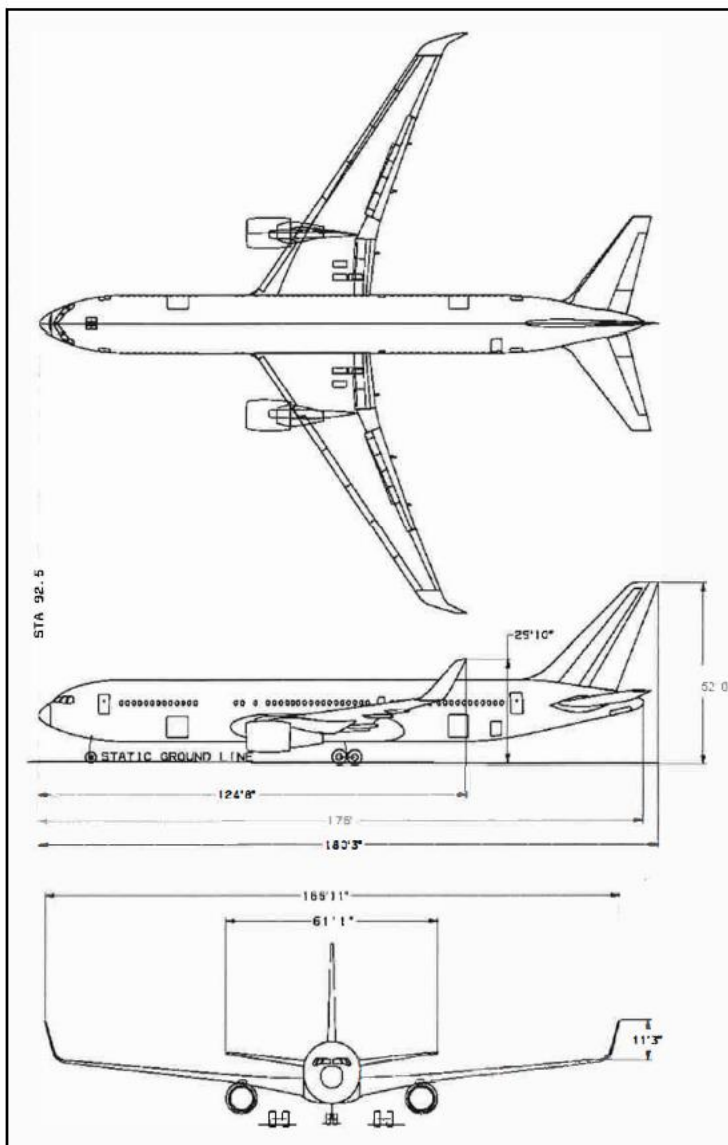
Figure 1: B-767-300BCF Winglet-installed airplane dimensions.¹⁰⁷

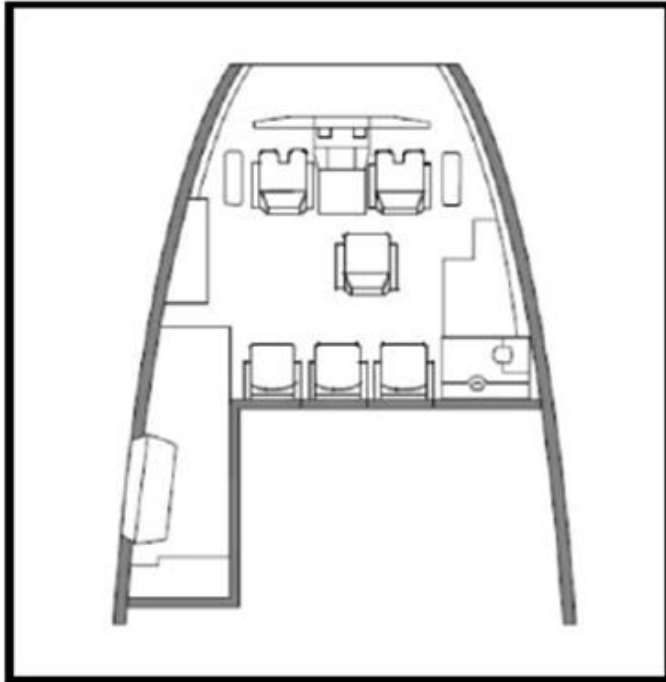
The B-767-300BCF flight deck occupant seating arrangement is shown below (see Figure 2). The locations represent the operating crew and authorized flight deck personnel seated at takeoff positions. The total occupancy, including flight deck and supernumeraries, was not to exceed six (6). The supernumerary area was part of the flight deck, and furnishing items in the supernumerary area included the galley, lavatory, and cargo area access door.

Figure 2: Boeing 767-300BCF cockpit configuration.¹⁰⁸

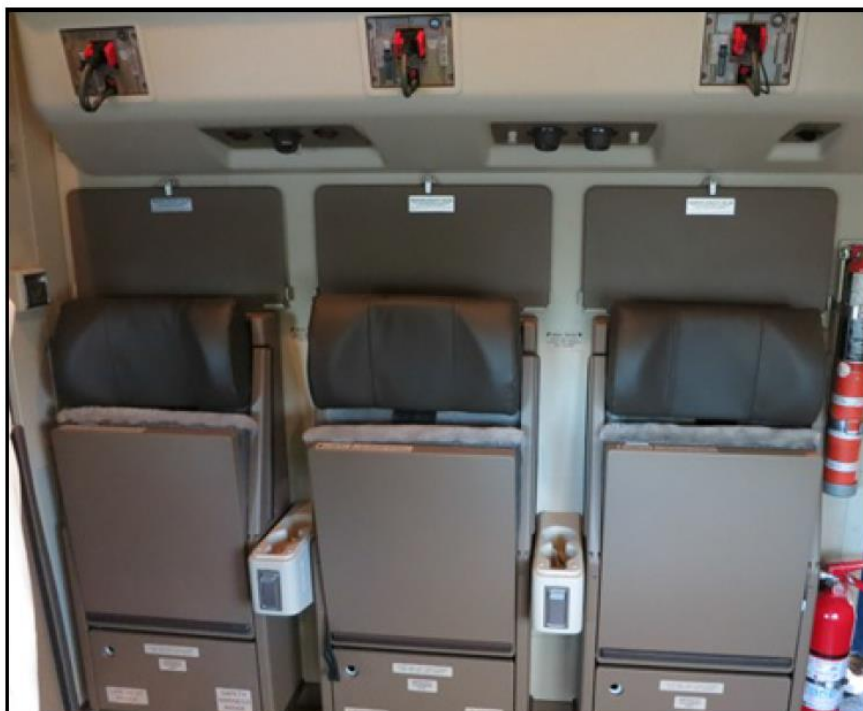
Figure 5.2.4. B767-300BCF Supernumerary Area

Photo 2: B-767-300BCF Supernumerary Area.¹⁰⁹

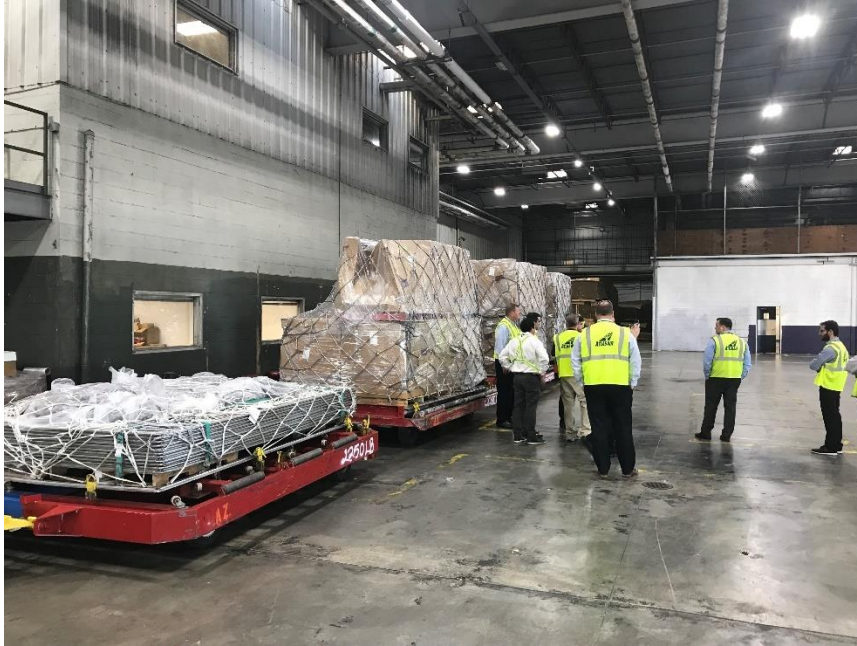
Photo 3: Atlas Air MIA cargo build-up hanger.¹¹⁶

StratAir personnel performed the build-up of the pallets in the warehouse and transport to airplane parking spot. StratAir used two scales on the hanger B side for measuring the weight of the cargo. Calibration certification for each scale was every 30 days, and StratAir used a 1,000 pound concrete weight for daily scale checks. Each scale had a wall-mounted display with a digital readout of the weight in pounds, shown in increments of 10 pounds.

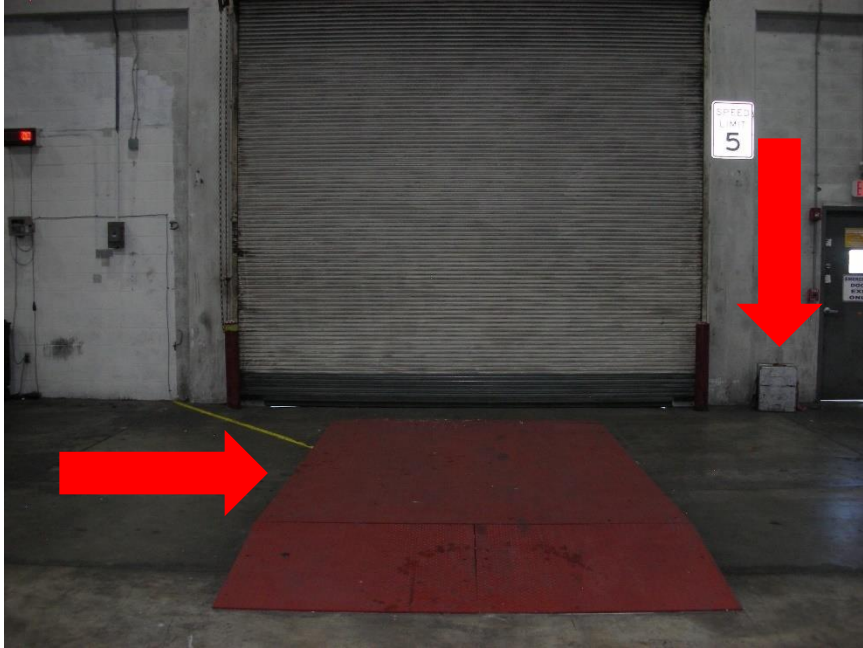
Photo 4: Cargo weighing area (the red arrow to the left indicates one to the hanger B scales, and the red arrow to the right indicates a 1,000 pound concrete weight).¹¹⁷

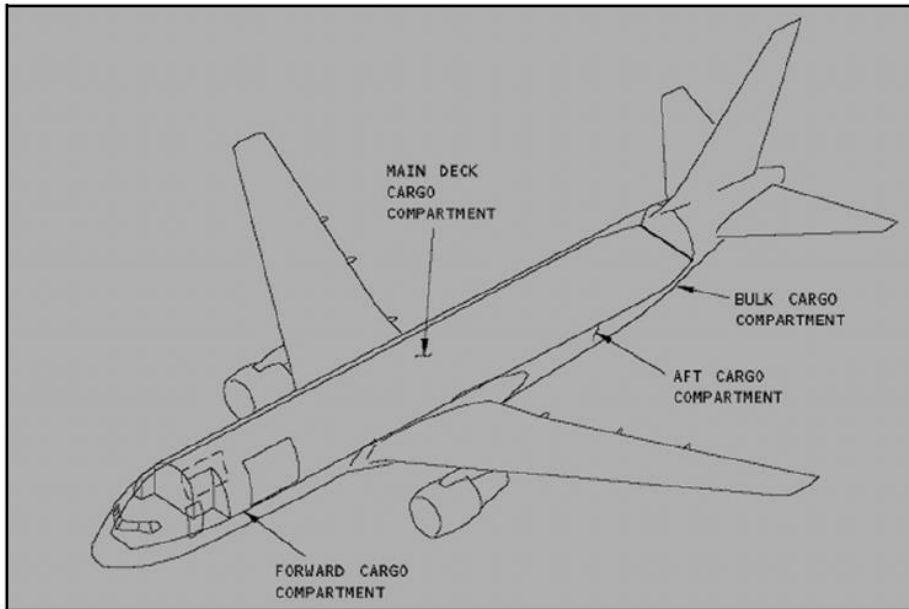
Figure 5: B-767-300BCF Cargo Compartment Configuration.¹²²

The B-767-300 main deck cargo compartment was a Class E compartment¹²³ which was loaded using the main deck side cargo door. The main deck compartment could carry pallets and containers. The floor load limit for the entire main cargo deck was 250 pounds/square foot.

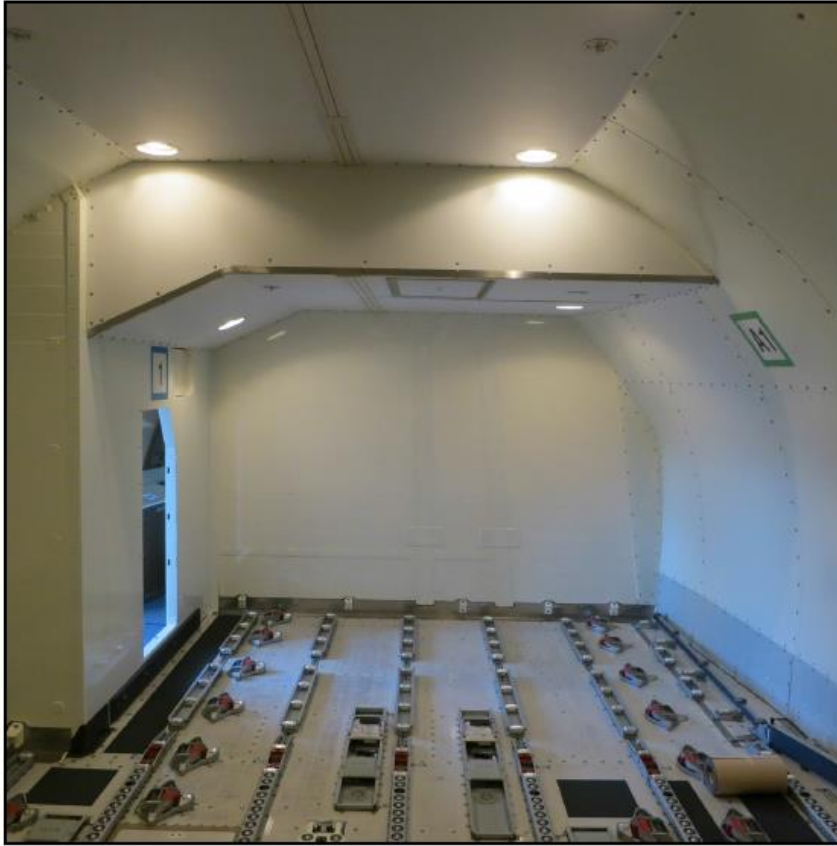
Photo 5: Main deck cargo compartment (looking forward) showing the cargo area access door to the flight deck on the left.¹²⁵

¹²⁸ The location of the empty pallet in position A2 left on the main deck would have allowed the flight crew access to the main deck via the cargo area access door in the aft portion of the cockpit.

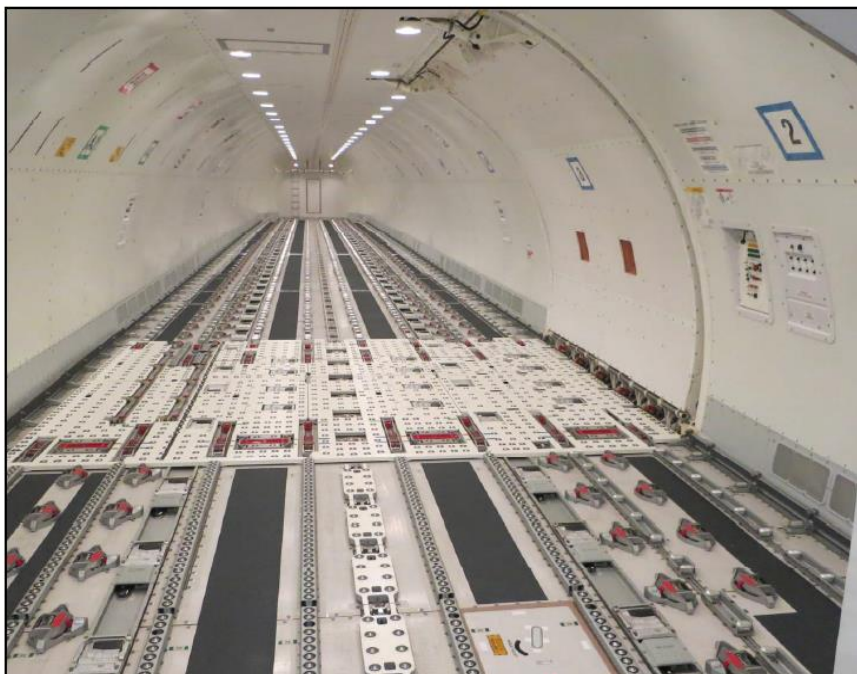
Photo 6: B-767-300BCF Main Deck Cargo Compartment.¹²⁶

The main deck of the accident airplane was loaded with seven (7) PAG and PAJ standard pallets.¹²⁷ One (1) empty pallet weighing 220 pounds was located in the forward main deck (position A2 left),¹²⁸ and six (6) pallets were located in the aft section of the main deck (positions A10 through A13). The pallets loaded in the aft portion of the main deck contained 45" x 60" Gaylord cardboard boxes secured to each pallet by netting. Each Gaylord contained contracted cargo from Amazon Prime. The total weight of the cargo on the main deck was 12,900 pounds.

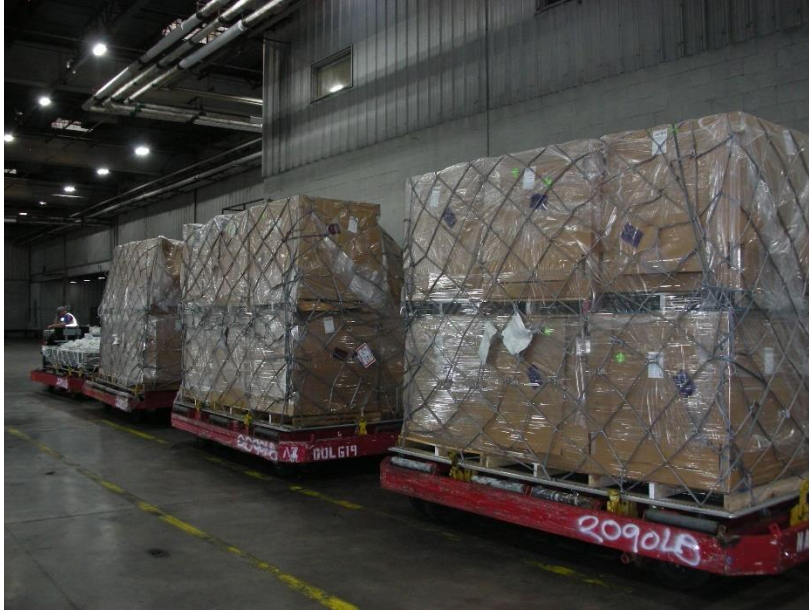
Photo 7: Sample Amazon Air load including palletized Gaylord boxes.¹²⁹

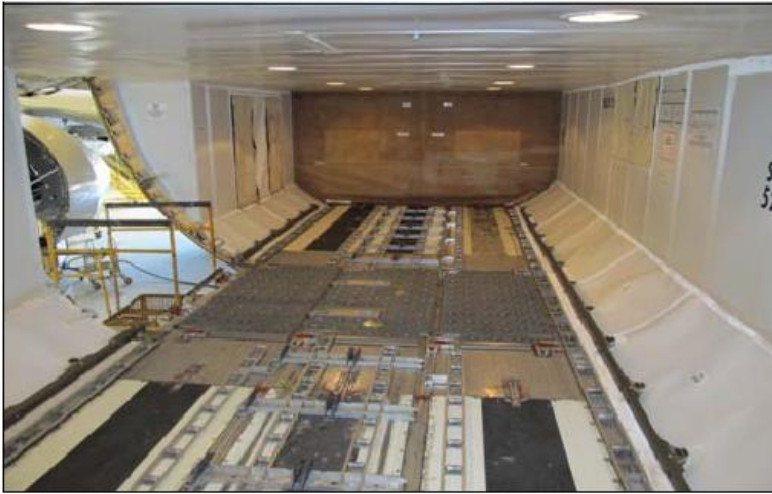
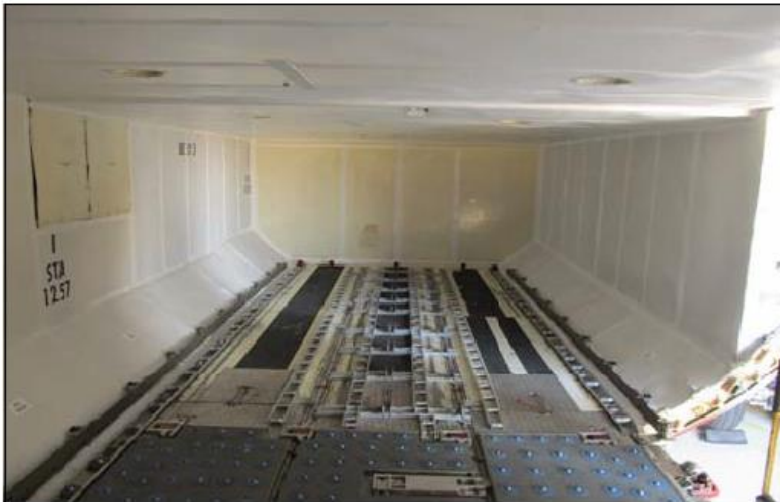
The B-767-300 forward and aft cargo compartments and bulk cargo compartment below the main cargo deck were Class C compartments.¹³⁰ Fire resistant compartment linings covered the insulation blankets above the cargo floor. The floor load limit for the lower forward and aft cargo compartments was 200 pounds/square foot.

Figure 2.6.20. B767-300SF Forward Lower Deck Compartment

Figure 2.6.21. B767-300SF AFT Lower Deck Compartment

Photo 8: B-767-300BCF Lower Deck Cargo Compartment.¹³¹

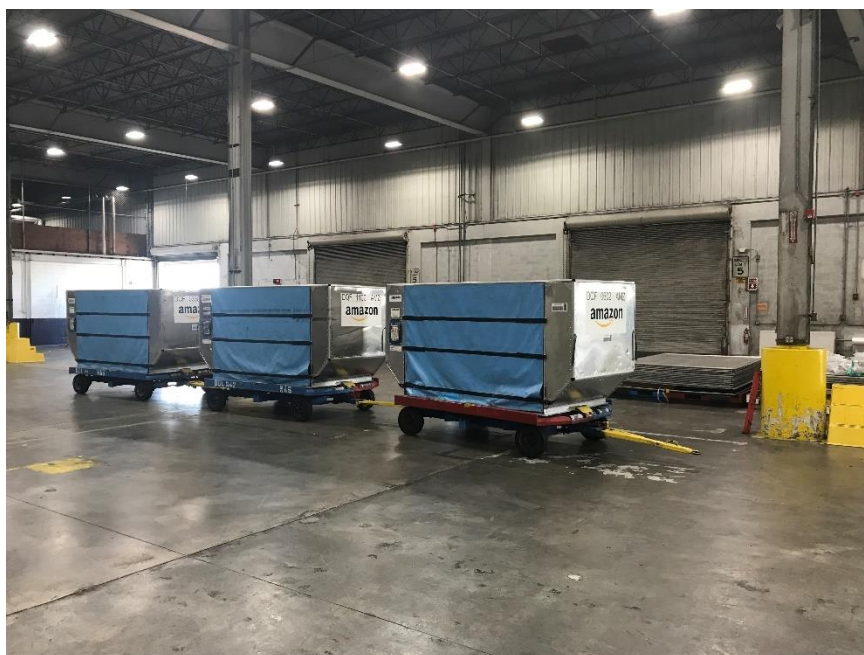
Photo 9: Photo of sample DQF containers used in the lower cargo compartment on a B-767.¹³³

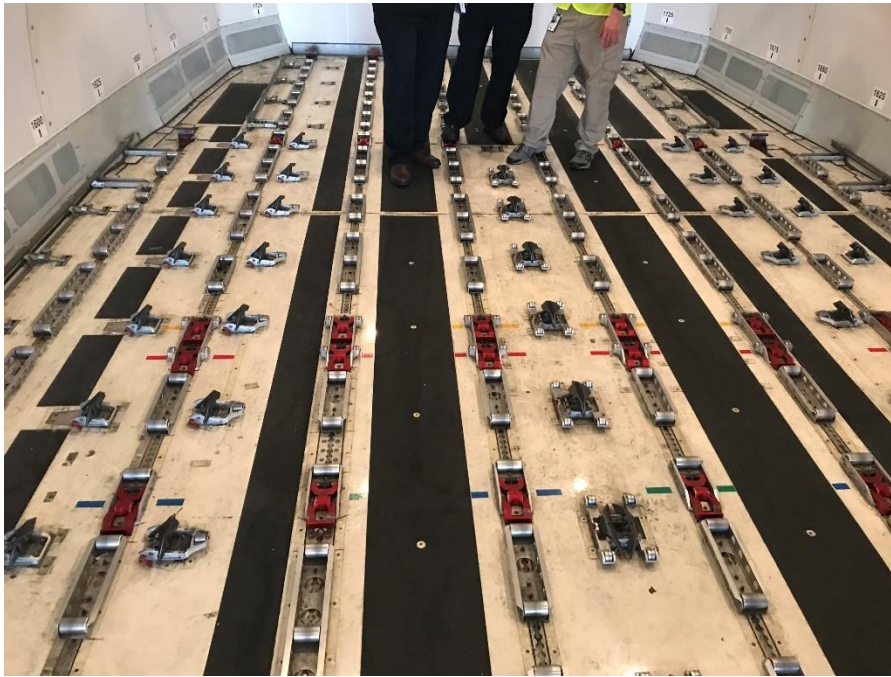
The B-767-300BCF main cargo deck floor contained floor lock assemblies designed to provide restraint for ULDs in certain cargo loading configurations. According to cargo loader interviews and statements, procedurally upon completion of loading and securing of the main deck cargo pallets and/or ULDs, all unused floor lock assemblies on the main deck were placed in the up position as an additional safety measure to mitigate the likelihood of a cargo shift.

Photo 10: Photo of B-767 exemplar airplane showing main cargo deck floor and floor lock assemblies.¹³⁶

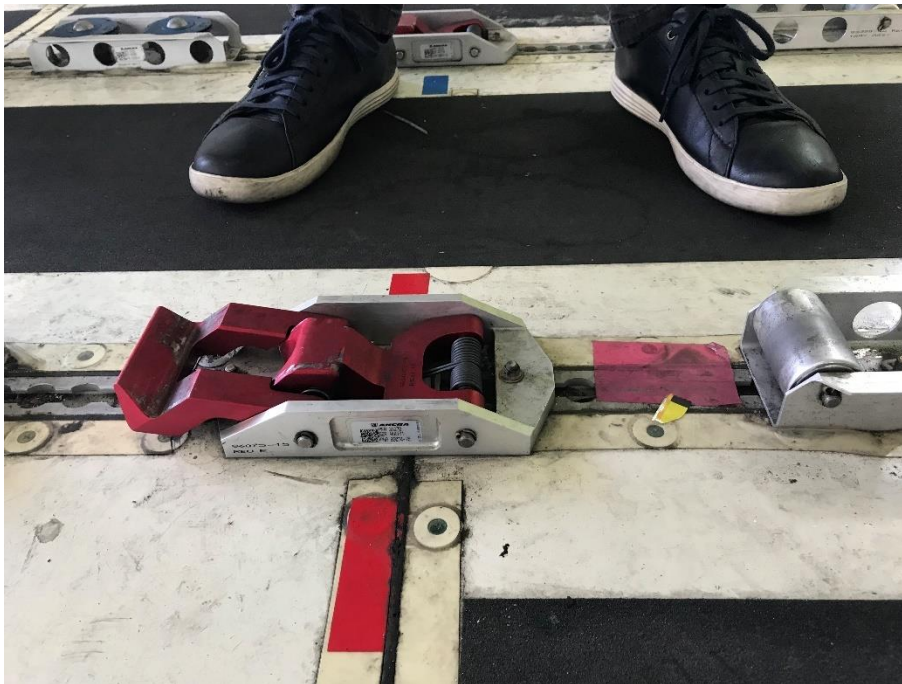
Photo 11: Close-up photo of B-767 exemplar airplane showing main cargo deck floor lock assembly (down and unlocked position).¹³⁷

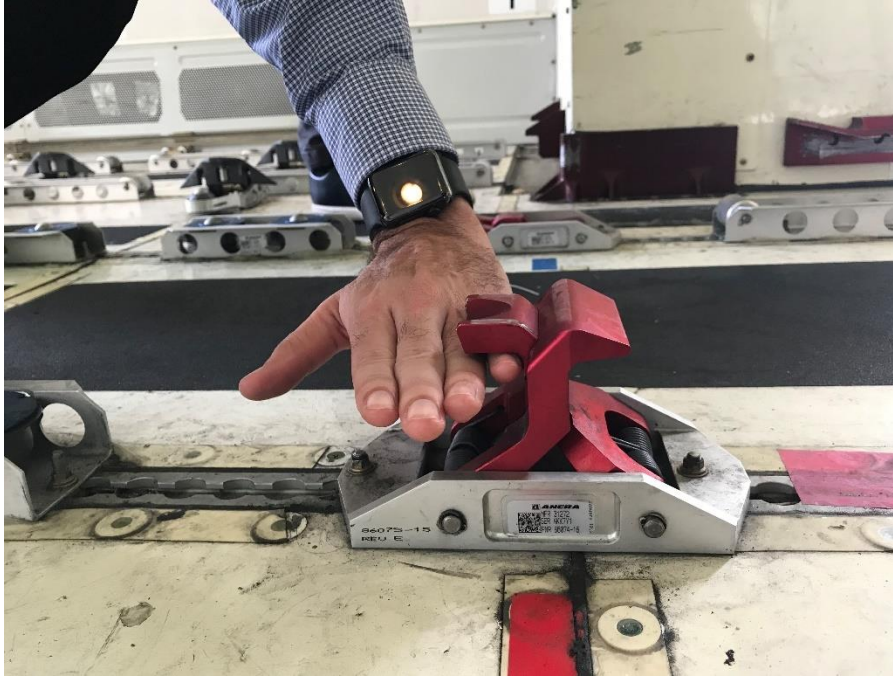
Photo 12: Close-up photo of B-767 exemplar airplane showing main cargo deck floor lock assembly (up and locked position).¹³⁸

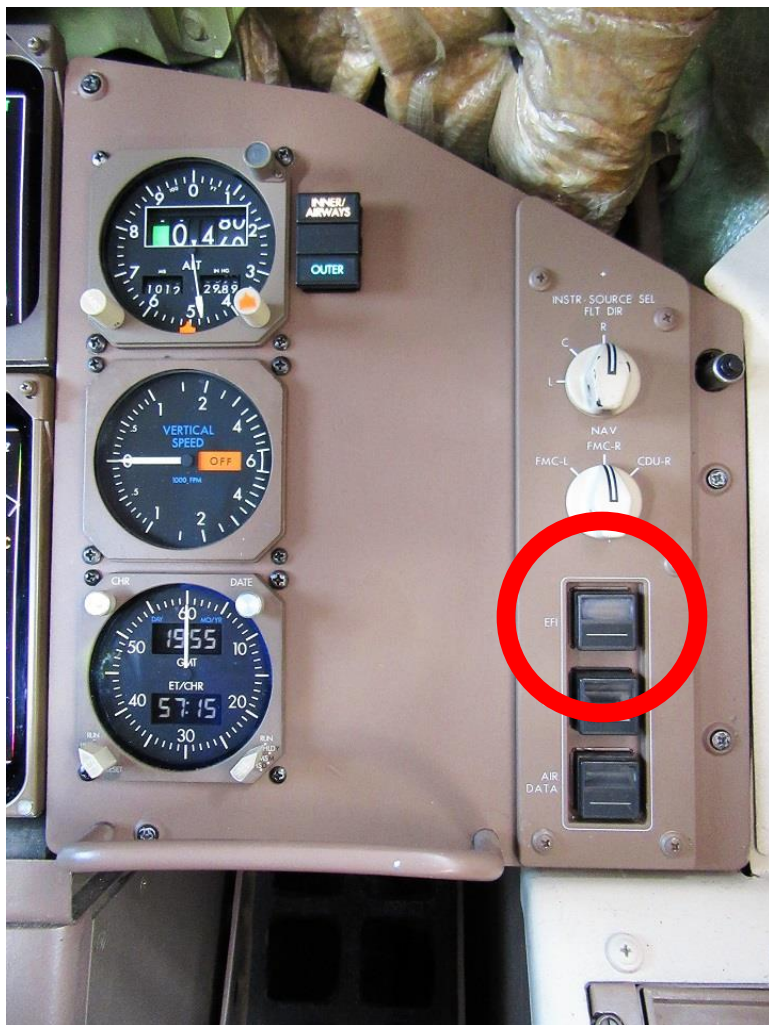
Photo 13: Photo showing Right Instrument Source Selector Panel (Lower) located on the right (FO) side of the forward control panel on the accident airplane (the EFI switch is indicated by the red circle).¹⁵⁹

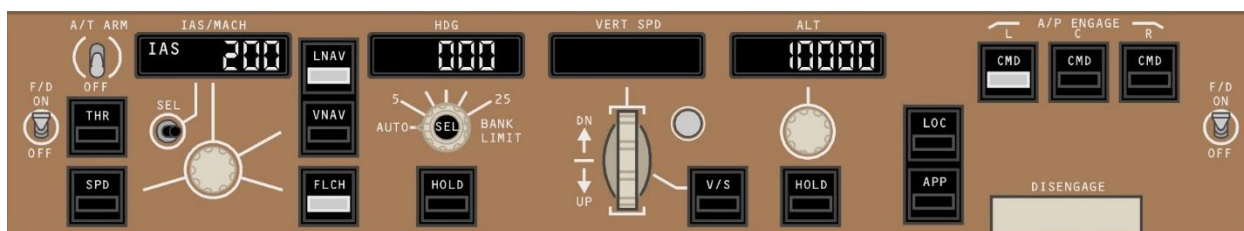
Figure 13: B-767-300 Mode Control Panel (MCP), located on the center glareshield in the cockpit.¹⁶⁰

The AFDS may be used to fly the airplane through pilot-selected direct control inputs from the Mode Control Panel (MCP) or through the computer generated inputs from the FMCs.

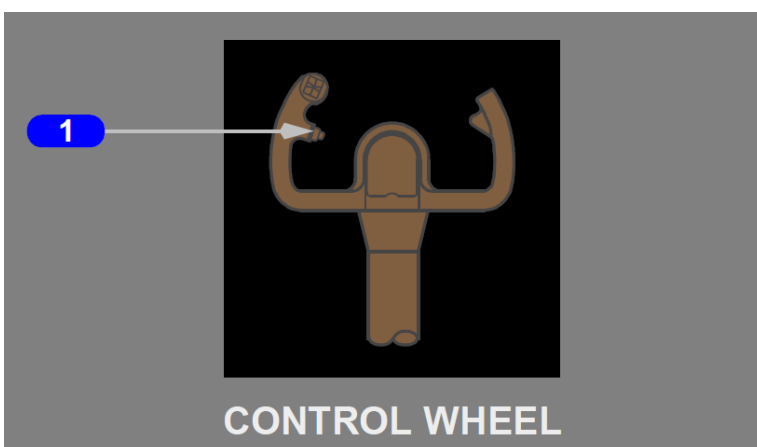
Figure 14: B-767 Autopilot Disengage Switch (indicated by the number “1” in the figure).¹⁶¹

Normal autopilot disengagement was through either control wheel autopilot disengage switch. The autopilots could also be disengaged by the MCP autopilot disengage bar. The A/P DISC illuminates and the EICAS warning message AUTOPILOT DISC would display with disengagement (manually or automatically).

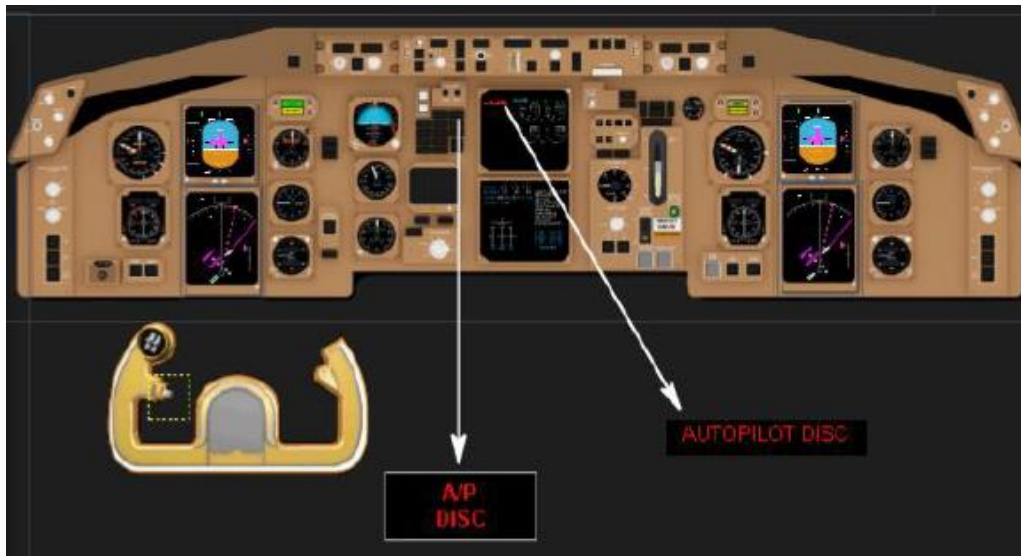
Figure 15: B-767-300 Autopilot disengagement alerts.¹⁶²

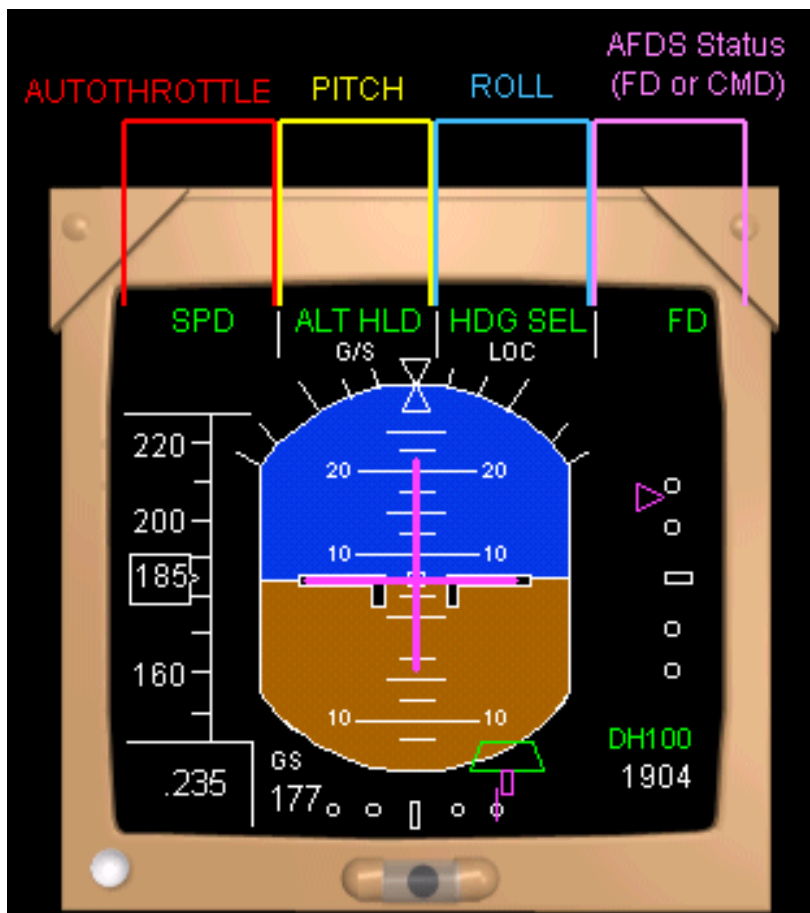
Figure 16: Flight Mode Annunciator.¹⁶⁴

When the GA was engaged, the AFDS controls pitch and roll while the A/T increased thrust to establish a 2,000 foot per minute climb. The FMA annunciations would be GA, GA, GA, CMD when an autopilot was engaged. The FMA annunciations would be GA, GA, GA, FD (flight director only) if the Flight Director was on and no autopilots were engaged.

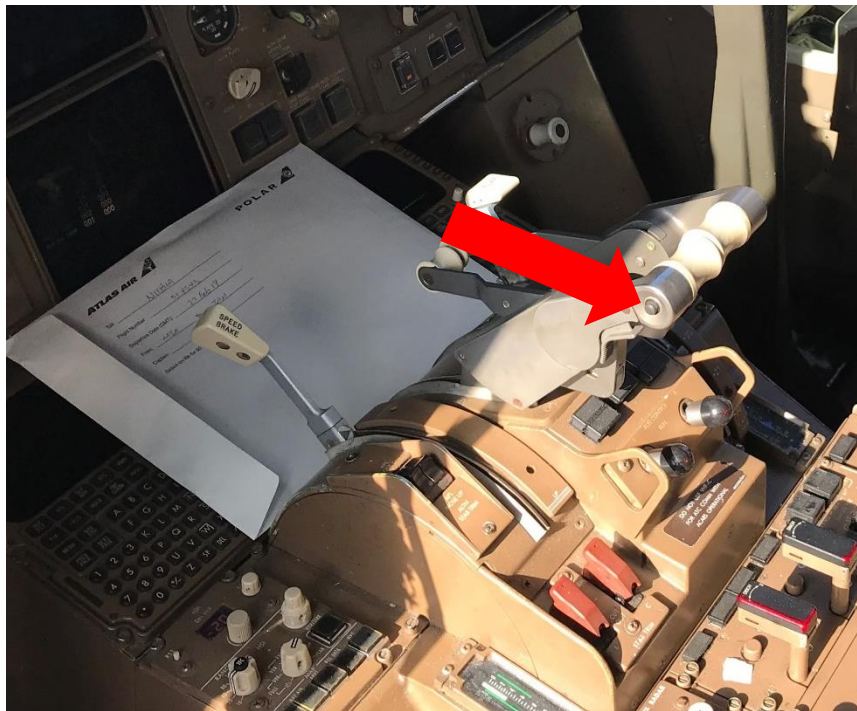
Photo 14: Photo of exemplar B-767 showing location of the autothrottle disconnect switches (the left throttle disconnect switch is indicated by the red arrow).¹⁶⁵

The autothrottle system could be disconnected manually by positioning the A/T arm switch on the glareshield to OFF, or by pushing either thrust lever A/T disconnect switch. Autothrottle disconnect occurred if a fault in the active autothrottle mode was detected, or when a reverse thrust lever was raised to reverse idle. The A/T DISC light illuminated and the EICAS caution message AUTOTHROT DISC displayed when the autothrottle is disconnected.

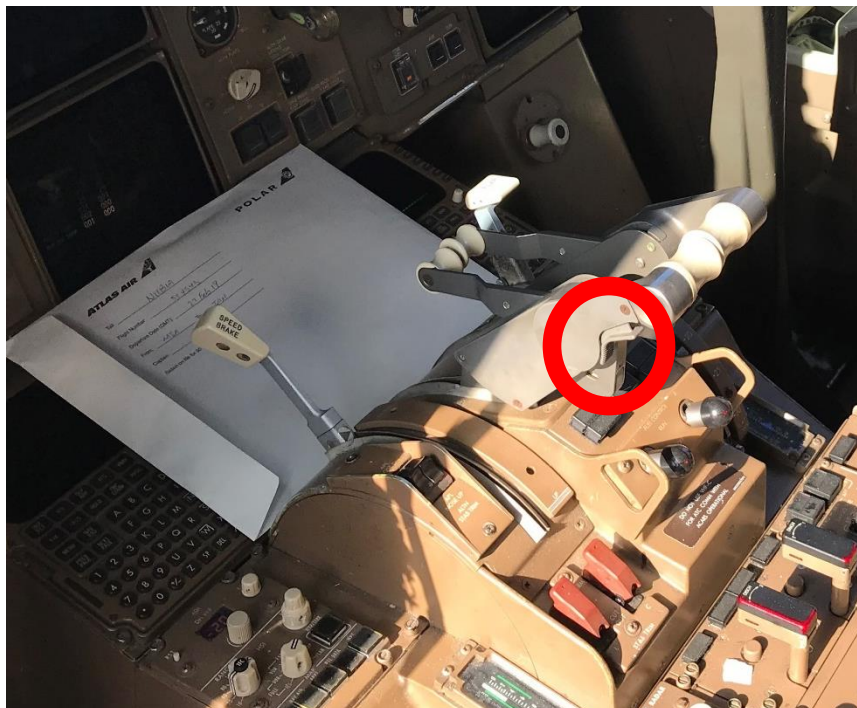
Photo 15: Photo of exemplar B-767 showing location of the go-around switches (the left go-around switch is indicated by the red circle).¹⁶⁷

As previously mentioned, about a minute before the accident the FDR recorded activation of the GA mode. The GA mode was engaged by pressing either of the go-around switches (left or right).

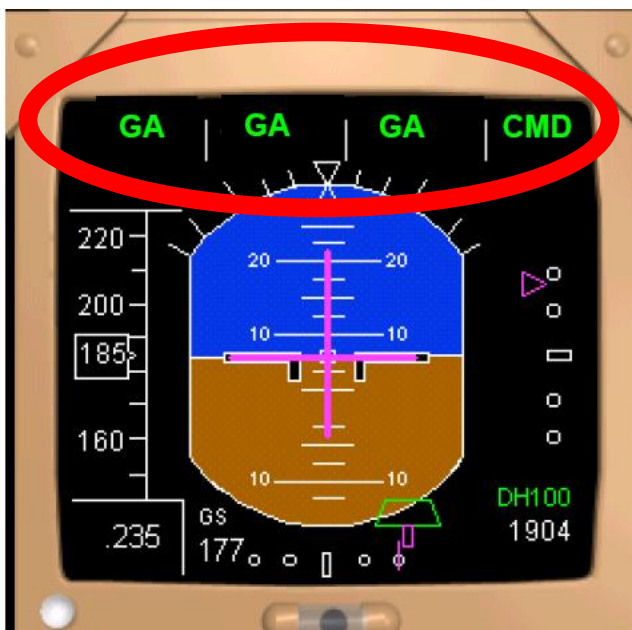
Figure 18: Go-around annunciations on the FMA (indicated by red circle).¹⁶⁸

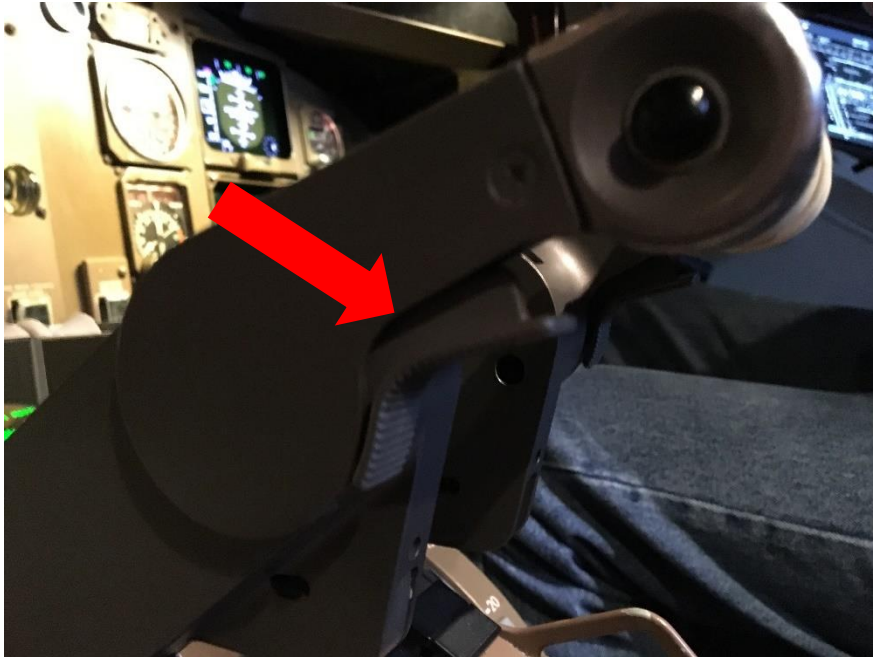
Photo 16: Close-up of the B-767 go-around switches (the left go-around switch is indicated by the red arrow).¹⁷⁰

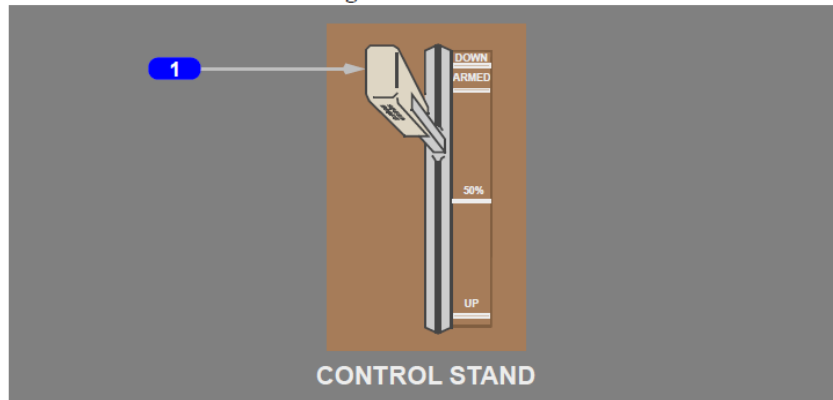
Figure 19: B-767 Speedbrake Lever (indicated by the number “1” in the figure).¹⁷¹

Load alleviation prevented the speedbrake from moving beyond the 50% position.

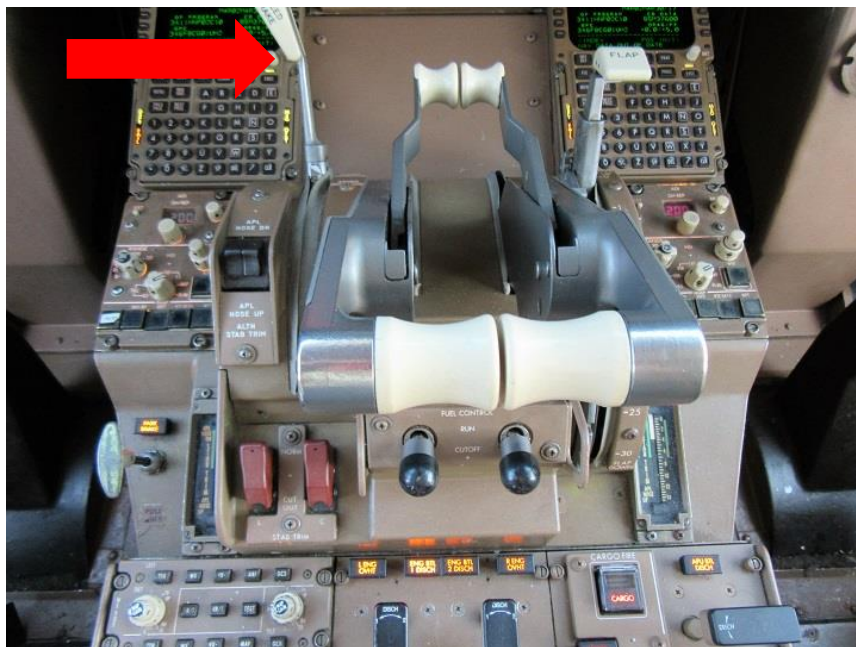
Photo 17: Photo of accident B-767 showing location of the speedbrake handle to the left of the thrust levers (the speedbrake handle is indicated by the red arrow).¹⁷²

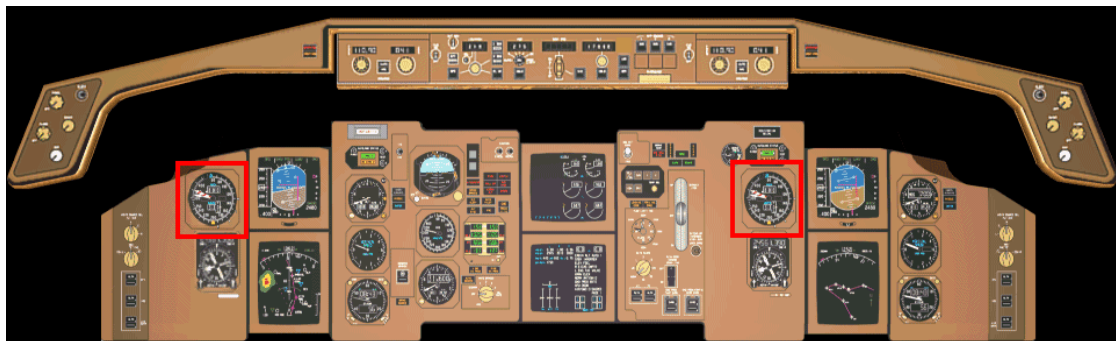
Figure 23: B-767 cockpit layout with location of conventional airspeed indicators (indicated by red boxes).

The B-767 was also equipped with two electric mach/airspeed indicators that displayed airspeed, Mach and V_{MO} from the selected air data source.

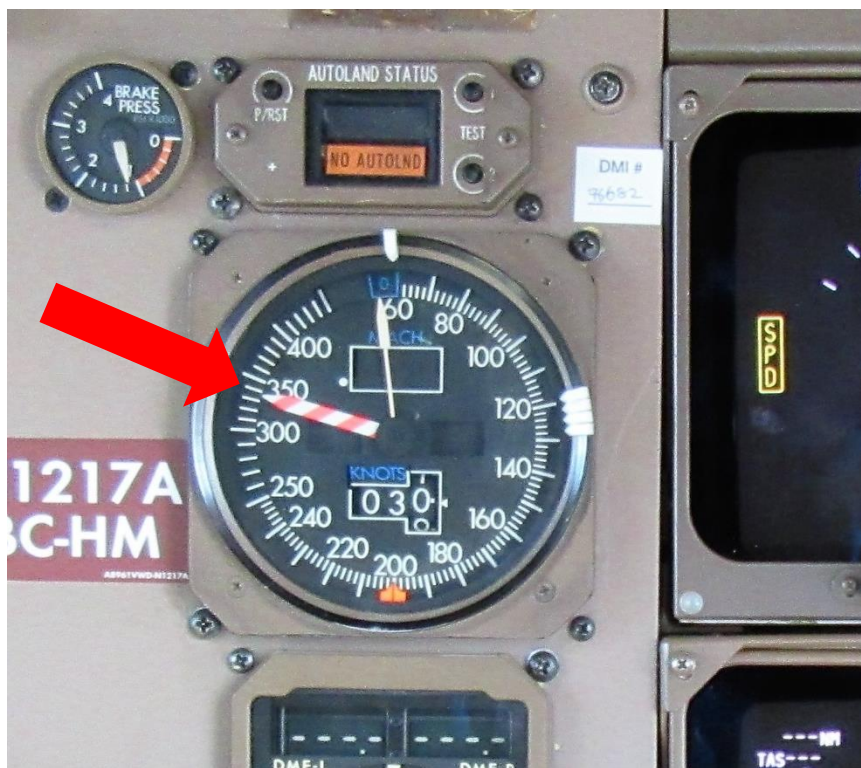
Photo 18: Photo of FO's conventional airspeed indicator on the accident airplane (the VMO pointer is indicated by the red arrow)..¹⁷⁸

The V_{MO} pointer indicated the maximum operating airspeed in knots or the equivalent to the maximum operating mach number. The command airspeed bug on each indicator could be automatically positioned from the FMC, or manually from the MCP IAS/MACH selector on the MCP.
